MODEL 163.113 /136 /154 /172 /174

16.3.00	Supersedes STI no. 72.19-011 dated 15.03.00		
---------	---	--	--

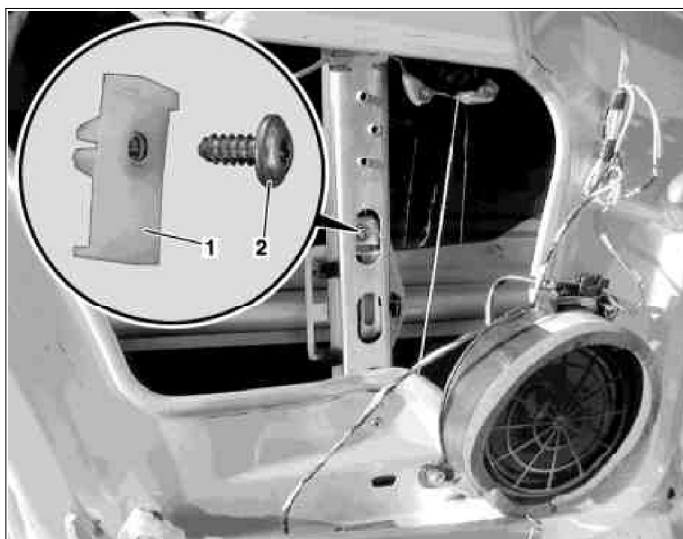
P67.30-2038-11

Damage Code	Cause	Remedy	
	Loose window lift mechanism attachment rivets, or failure of the window mounting clip to sufficiently hold window during initial movement.	1 Inspect window lift mechanism attachment rivets and ensure that assembly is securely mounted  <b>i</b> If attachment rivets loose #	
		2.1 Replace attachment rivets	
		3 Inspect window mounting clip (1) and window glass during upward and downward operation  <b>i</b> If movement is detected between window mounting clip (1) and window glass #	
		4.1 Replace window mounting clip (1) AND screw (2)	
		<b>!</b> Apply Loctite® to threads of new screw. <b>i</b> A <b>new</b> window mounting clip and screw should be used whenever repairs are made that require removal of crank window. <b>Nm</b>	*BR00.45-Z-1013-02A  *BA72.12-P-1006-01C

- 1 Window mounting clip  
2 Screw
