DTB

Date: June 4, 2009
 Order No.: S-B-83.30/74p
 Supersedes: S-B-83.30/74o dated April 29, 2009
 Group: 83

**SUBJECT: All Model 164, 171, 203, 204, 209, 211, 215, 216, 219, 220, 221, 230 and 251 Vehicles
 Air Conditioning Musty/Moldy Odor Complaints**

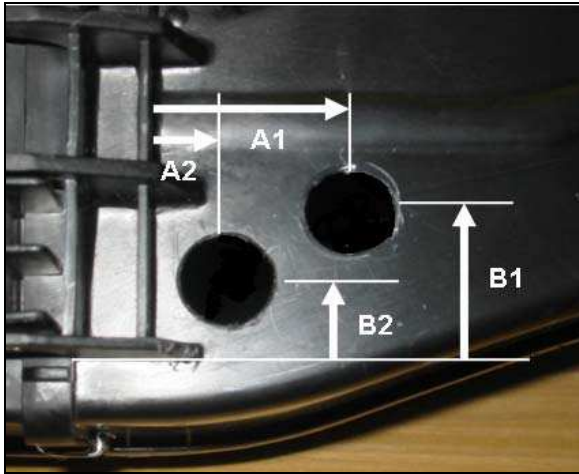
Figure 1 P-B-83.30/74h
Without foam block as in WIS AR83.30-P-5555-01A

Dimension A1 = 30 mm
Dimension B1 = 25 mm

Dimension A2 = 10 mm
Dimension B2 = 15 mm

climate housing to access the evaporator with the spray probe. The location for drilling the hole is described in WIS document AR83.30-P-5555-01A and Figure 1, A1 and B1.

2. A white foam block may be mounted to the housing between the blower motor and the main section of the case, see (Figure 2). On these housings, there is an alternate location of the hole as shown in Figure 1, A2 and B2.
