AF88.70-P-1100AG	Wind noise at outside mirror on left and/or right front door	30.10.03	Ì
------------------	--	----------	---

MODEL 163.154 #A as of 289560, 163.113 /128 #X as of 754620, 163.113 /174 #A as of 289560 up to 486952, 163.128 /157 /175 #A up to 486952

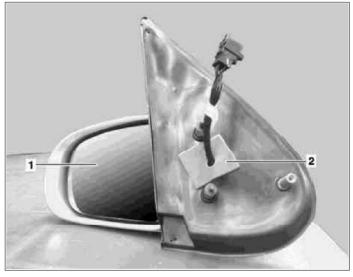
P88.70-2311-11

Damage Code	Cause	Remedy	
81 101 39	Insufficient seal pressure between door and	1 Remove outside rearview mirror (1) only on side where wind noise occurs.	AR88.70-P-9000GH
	base of mirror mount.	on side where wind noise occurs.	*110589035900
		2 Install foam (2) onto base of mirror mount around wiring harness.	
		3 Reinstall outside rearview mirror (1).	AR88.70-P-9000GH
		i Replace foam on inside of door around hole where mirror wiring harness comes through.

- Outside rearview mirror
- 2 Foam
