ENGINE 112, 113 in MODEL 163.1## ## up to 357786
 ENGINE 112 in MODEL 202.02
 ENGINE 112 in MODEL 202.08
 ENGINE 112 in MODEL 210.06
 ENGINE 113 in MODEL 210.07
 ENGINE 112 in MODEL 210.663
 ENGINE 112 in MODEL 210.26# ## up to 276396
 ENGINE 113 in MODEL 210.27# ## up to 276396
 ENGINE 112, 113 in MODEL 210.08# ## up to 084039
 ENGINE 112, 113 in MODEL 210.28# ## up to 084039

Category	Op. no.	Operation text	Time	Acc. no.	Code
P	023813	Remove/install/replace gasket between intake pipe and throttle valve	006 WU/0.5 h	---	---

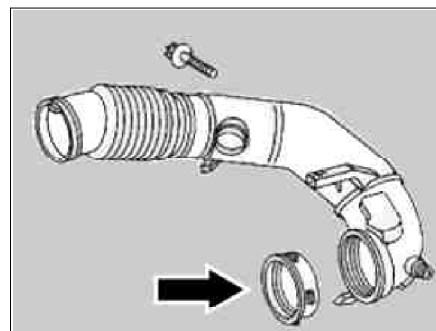
P07.07-2038-01

Damage code	Cause	Remedy	
14 034 04	Gasket (B) between intake pipe (A) and throttle valve defective. <i>i</i> High oil consumption of more than 0.8 liters per 1000 km.	<i>i</i> In order to avoid erroneous removal the following documents must be processed before starting the work: # High oil consumption Measure oil consumption	AF18.00-P-8044D AR18.00-P-0025AV
		1 Remove,/install/replace gasket (B) between intake pipe (A) and throttle valve.	AR07.07-P-1454A
		<i>i</i> Use new gasket according to parts ordering notes Old gasket with part number 112 141 01 80 should no longer be used.

A Intake pipe
 B Gasket

Part no.	Designation	Quantity
A 112 141 18 80	Gasket	1
