MODELS 163.113 /128 /136 /154 /157 /172 /174 /175

Vehicle illustrated up to 31.8.98

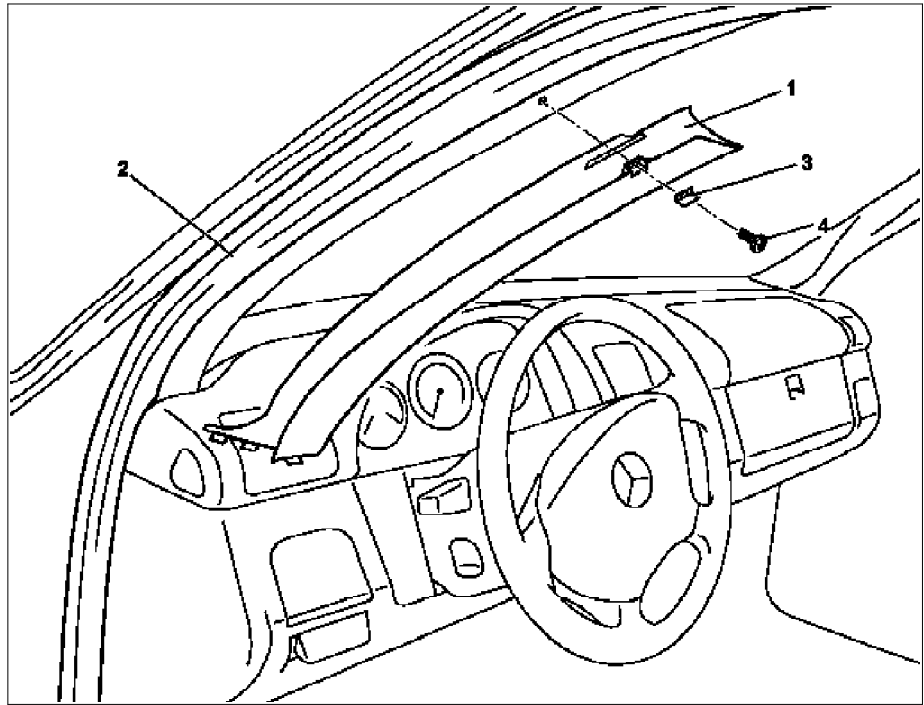
P68.30-0537-06

- 1 A-pillar paneling
- 2 Door rubber seal
- 3 Cover cap
- 4 Bolt

Remove/install		
1	Remove door rubber seal (2) in area of A-pillar		
2.1	Remove cap (3)	Up to 08/98.	
3.1	Unscrew screw (4)	Up to 08/98.	
4	Remove A-pillar paneling (1)	<p><b>i</b> The paneling is fastened in the instrument panel at the bottom with lugs and will be fastened with a clip at top as of 09/98.</p> <p><b>Installation:</b> Replace clip</p> <p>

Long wedge</p>	*115589035900
5	Install in the reverse order	<p><b>i</b> On vehicles up to 08/98, on which a new paneling should be installed, the upper area of the fixing opening at the top of the A-pillar must be enlarged so that the clip retainer of the paneling can be installed in the A-pillar.</p>
