MODEL 163.113 #A as of 289565,
163.113 #X as of 754620,
163.154 #A as of 289565,
163.128 /157 /175

P88.20-2200-09

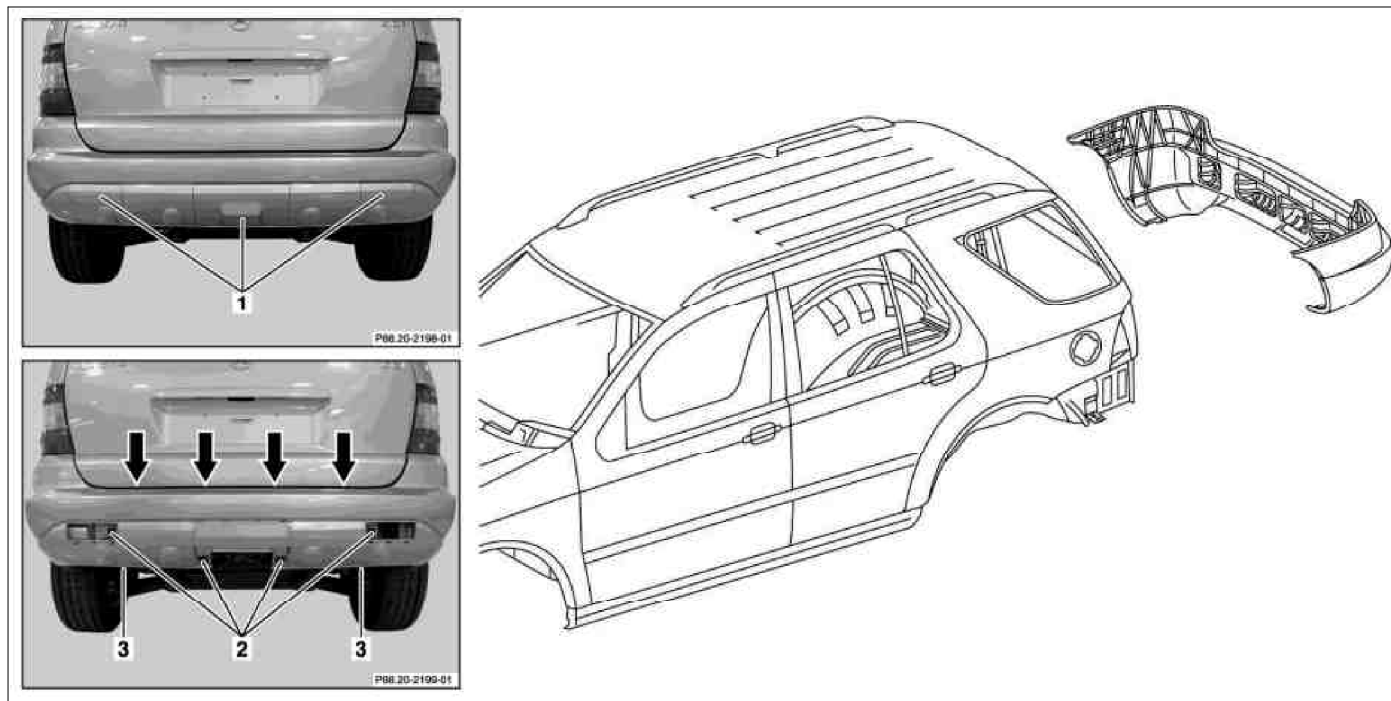
| | Remove/Install | | |
|---|--|---|---|
| 2 | Remove panelings (1) | Do not damage paint. Do not break off clips. Installation wedge | *115589035900 |
| 3 | Remove screws (2) | | *BA88.20-P-1008-01B |
| 5 | Pull bumper toward rear and remove | Do not damage paint/wiring harness. Pull directly over clips (arrows) and detach from bracket. Installation: Align bumper at tailgate and at taillamps | |
