AR47.10-P-4000GH Empty fuel tank if fuel pump is faulty

| MODEL | 163.113 with ENGINE 612.963 |

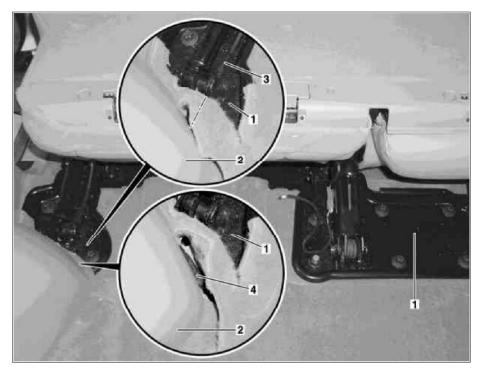
P47.20-2076-06

- Fondsitzkonsole 1
- Cover of left C-pillar Seat retaining cable 2
- 3
- 4 Wiring harness

| 1.1 | Unscrew bolts at rear of 2/3 seat bench and raise rear of seat bench | i Up to VIN A145272, X708318. | |
|---|--|---|---|
| 3.1 | Pull floor covering below rear seat mounting bracket (1) of 60% seat forward | Carefully pull floor covering forward under the seat console to prevent it from tearing. | |
| 4.1 | Pull the floor covering forward under the front corner of the left C-pillar cover (2) | () Carefully pull the floor covering forward under the cover to prevent it from tearing. | |
| 5 | Cut into floor covering directly behind seat retaining cable (3) | i Ensure that the wiring harness (4) is not damaged when cutting the floor covering. | |

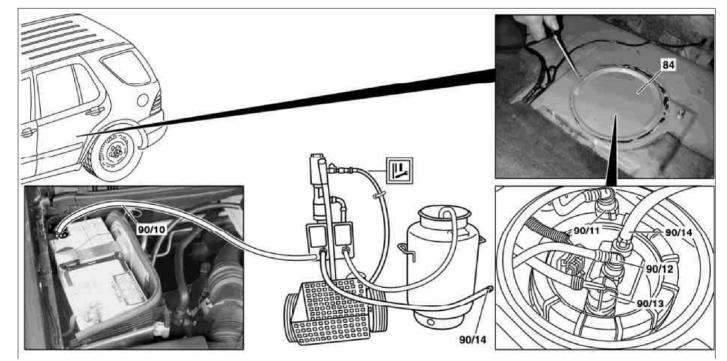
P47.10-2077-09

84 Closing cover

- 90/10 Ground line (vacuum unit)
- 90/11 Fuel return line

90/12 Fuel feed line 90/13 Stationary heater connection 90/14 Extraction hose

| 1.1 | Unscrew bolts at rear of 2/3 seat bench and raise rear of seat bench | i Up to VIN A145272, X708318. | |
|---|--|---|---|
| 7 | Remove end cover (84) of body | i Installation: Replace cap and insert with new sealing compound. | |
| 8 | Seal fuel return line (90/11) | S Pliers | *163589003700 |
| 9 | Connect extraction hose (90/14) with adapter hose to connection for fuel return line (90/11) | S Extraction hose | *168589009000 |
| 10 | Connect ground cable (90/10) of extraction pump ground terminal vehicle battery | | |
